**Pump Analysis Report
City of Rocky Mount
Pull and Inspect RWP #1
Job #32890**

CRU Job No-	32890
Customer-	City of Rocky Mount
Customer Contact-	
Pump Manufacturer-	Fairbanks-Morse
Model/Stage(s)/Serial	16"-8312 / 2 stg. / N.A.
GPM / Head / HP	7600 GPM / 45' TDH / 100 HP
CRU Project Manager-	Zach Hinnant zhinnant@crupumps.com / (919)-775-2463

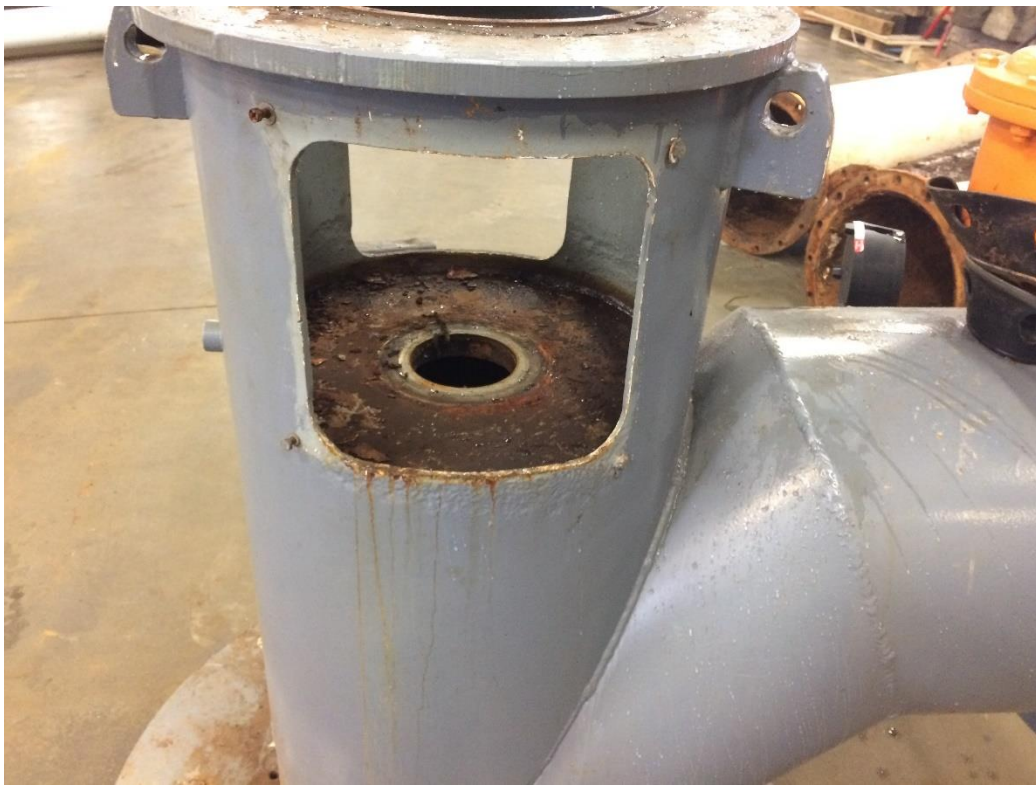
Figure 1: The discharge head is in reusable condition requiring sand blasting and a new coating of two-part epoxy.

- 1) The discharge head and tension assembly are in reusable condition. Both will require sand blasting and a new coat of two-part epoxy. The tension assembly will also need to be rebuilt with a new tension bearing, packing, and hardware.

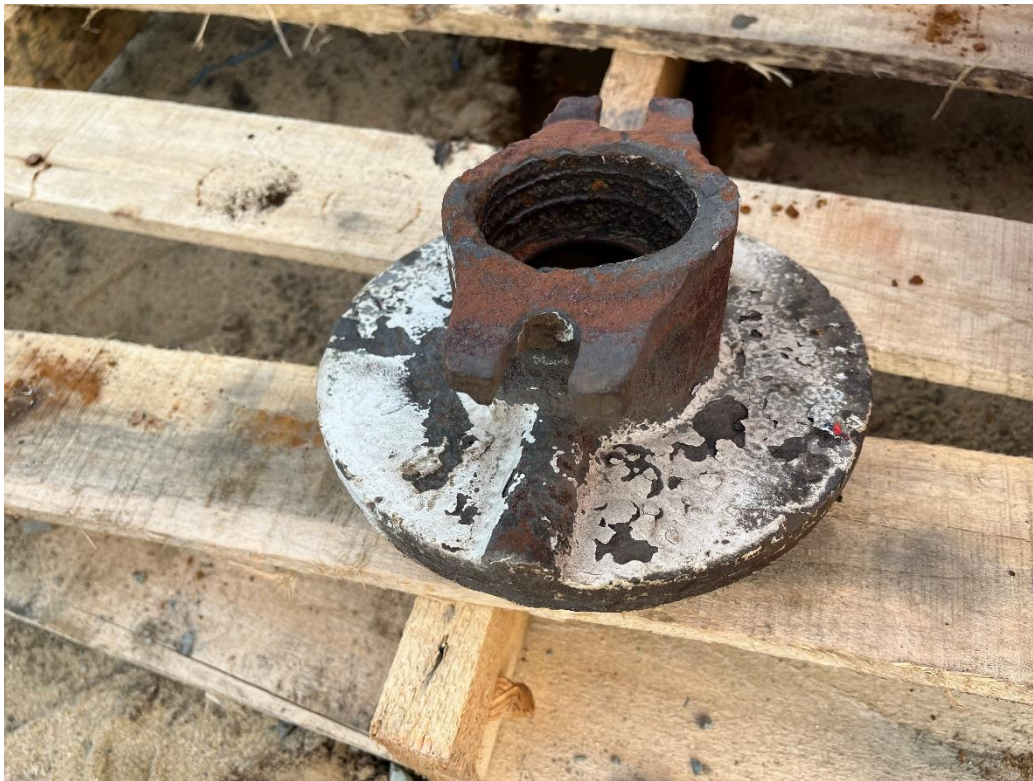
Figure 2: The tension assembly was found to be in reusable condition. It will need to be rebuilt with a new tension bearing and packing.

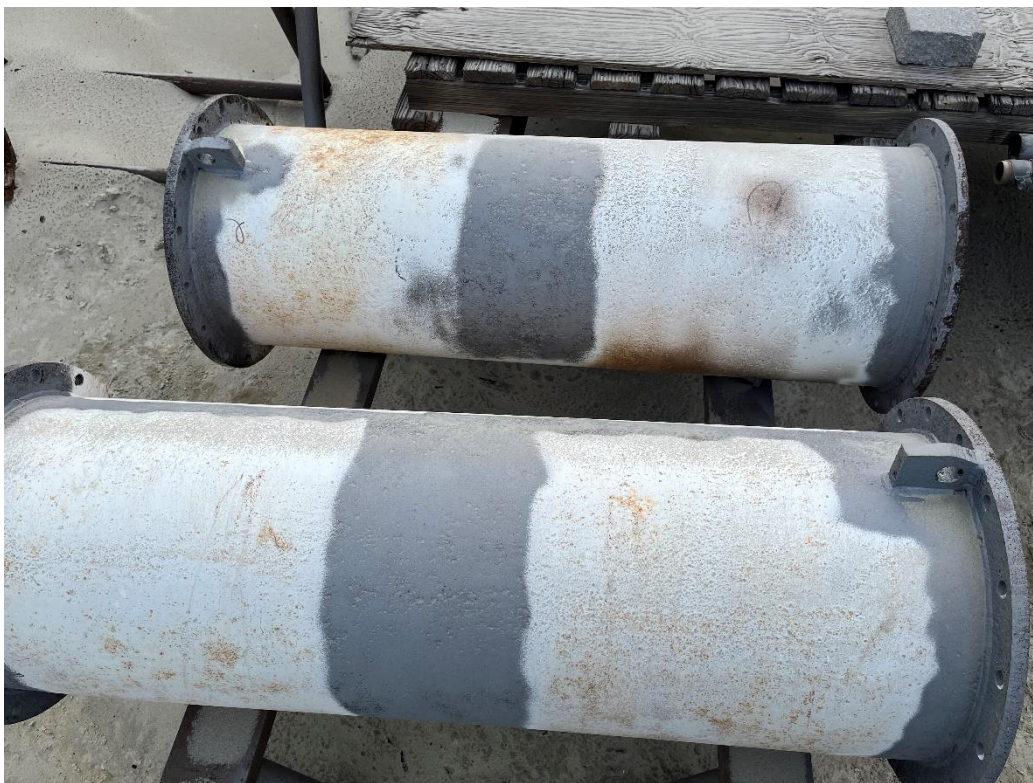
Figure 3: All column pipes were inspection blasted and found to be in reusable condition. They will need a new coat of two-part epoxy.

- 4) The column pipes were inspection blasted and found to be in reusable condition. All pipes show some slight pitting, but that can be corrected with a new coat of two-part epoxy.

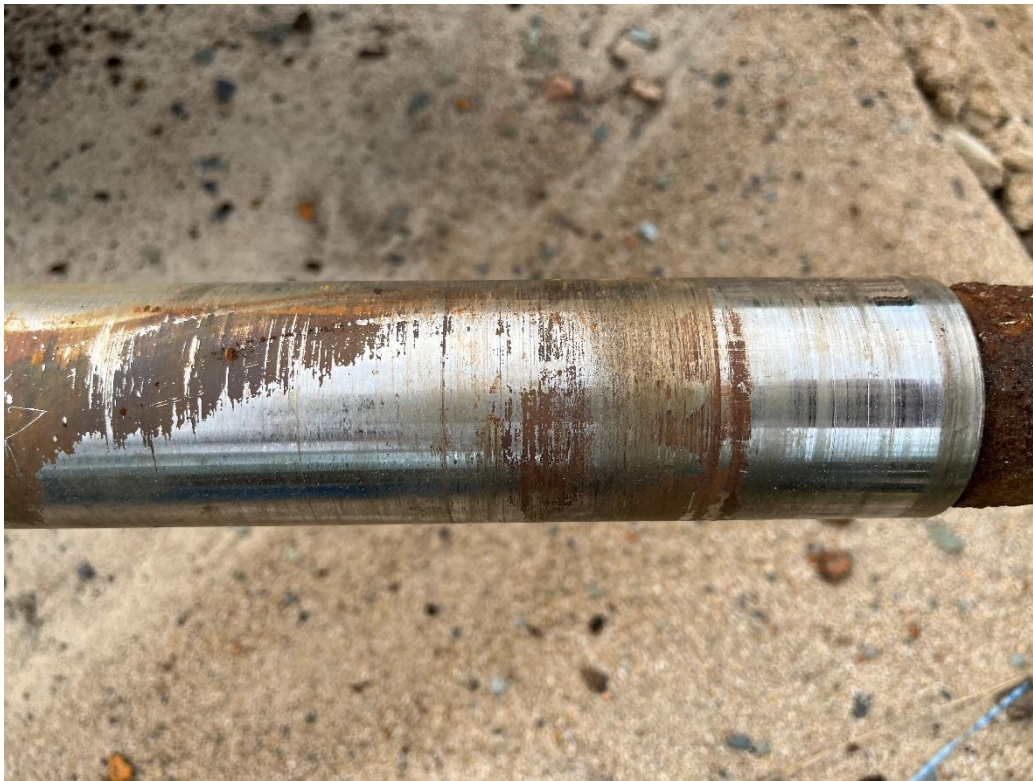
Figure 4: Top shaft is worn in the enclosing tube bearing area and the sleeve is worn from the tension bearing and packing. Both will need to be replaced.

- 2) The motor shaft and three-piece coupling are in reusable condition. Both will need to be cleaned, and the motor shaft will need to be polished and straightened. The top shaft is worn in the enclosing tube bearing area, and the top shaft sleeve is worn from the tension bearing and packing. The line shafts are worn from the enclosing tube bearings and cannot be reused. All shafting and the top shaft sleeve will need to be replaced.

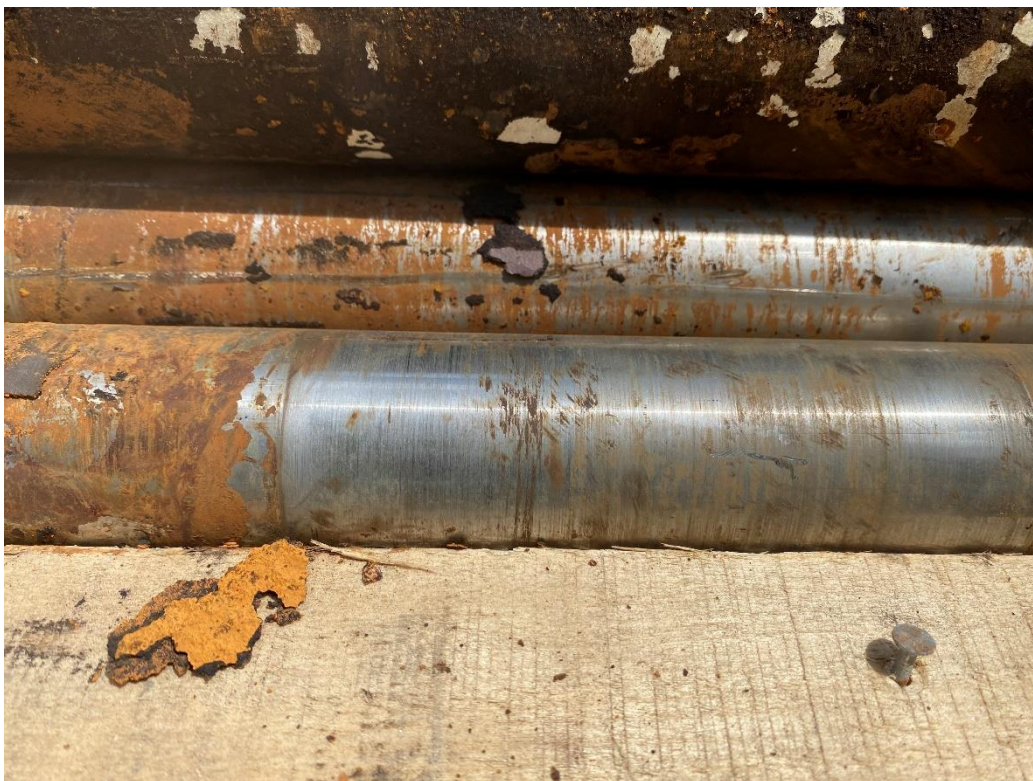
Figure 5: The line shafts are worn in the enclosing tube bearing areas and will need to be replaced.

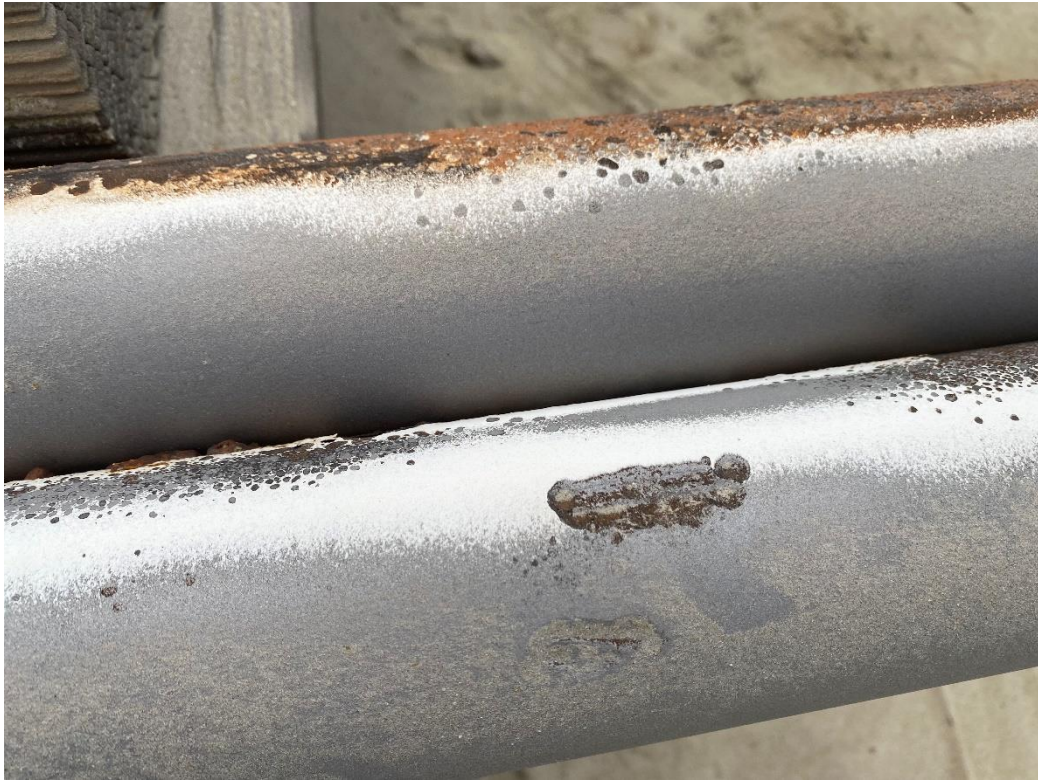
**Figure 6: The enclosing tubes are pitted and are not in reusable condition.
All enclosing tubes will need to be replaced.**

- 3) The enclosing tubes are corroded and are not in reusable condition. The enclosing tube bearings are worn and cannot be reused. All tubes and tube bearings will need to be replaced.

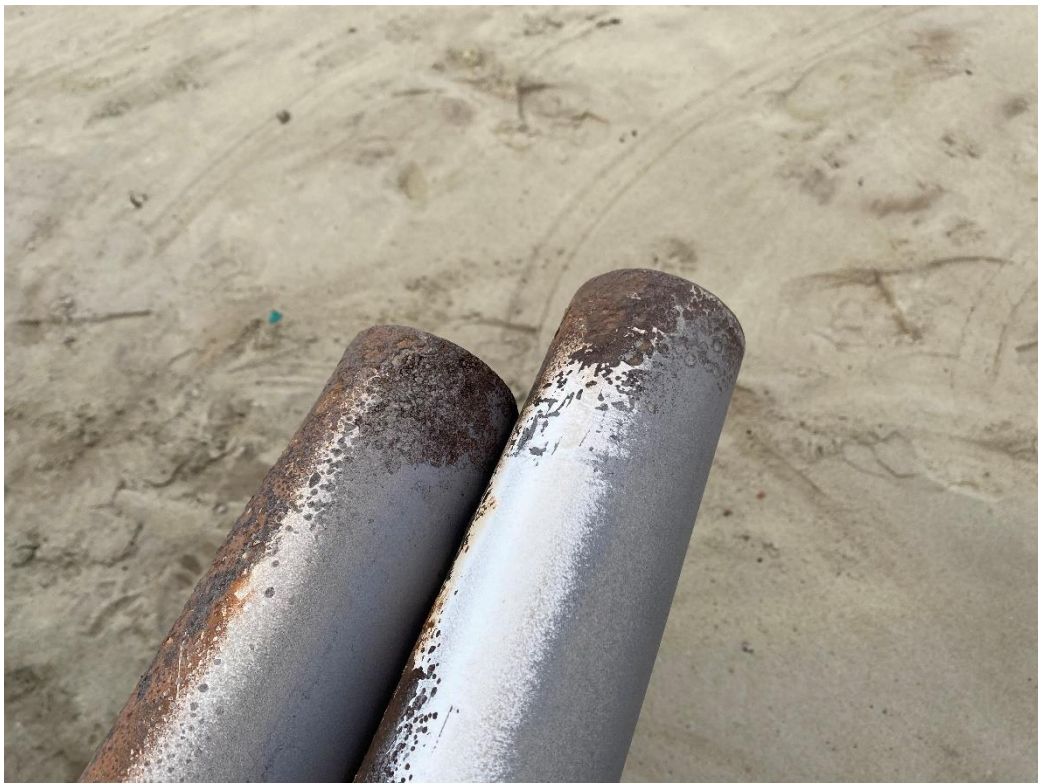
Figure 7: Detail showing the pitting on the ends of the tubes.

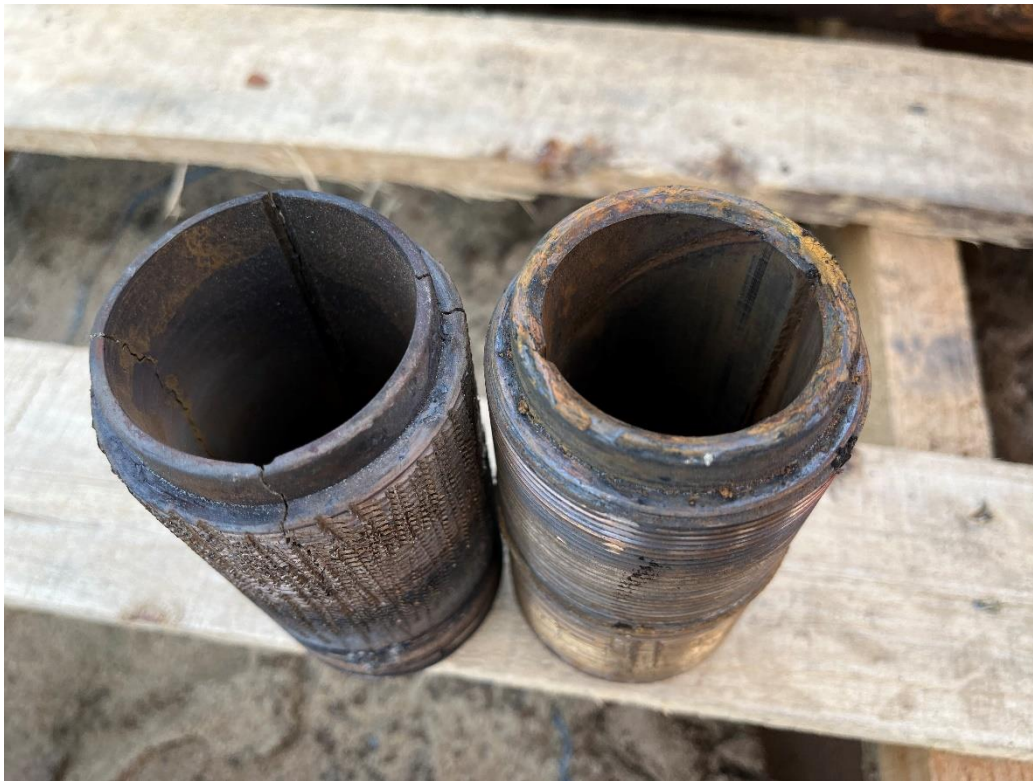
**Figure 8: The enclosing tube bearings are worn and cannot be reused.
All tube bearings will need to be replaced.**

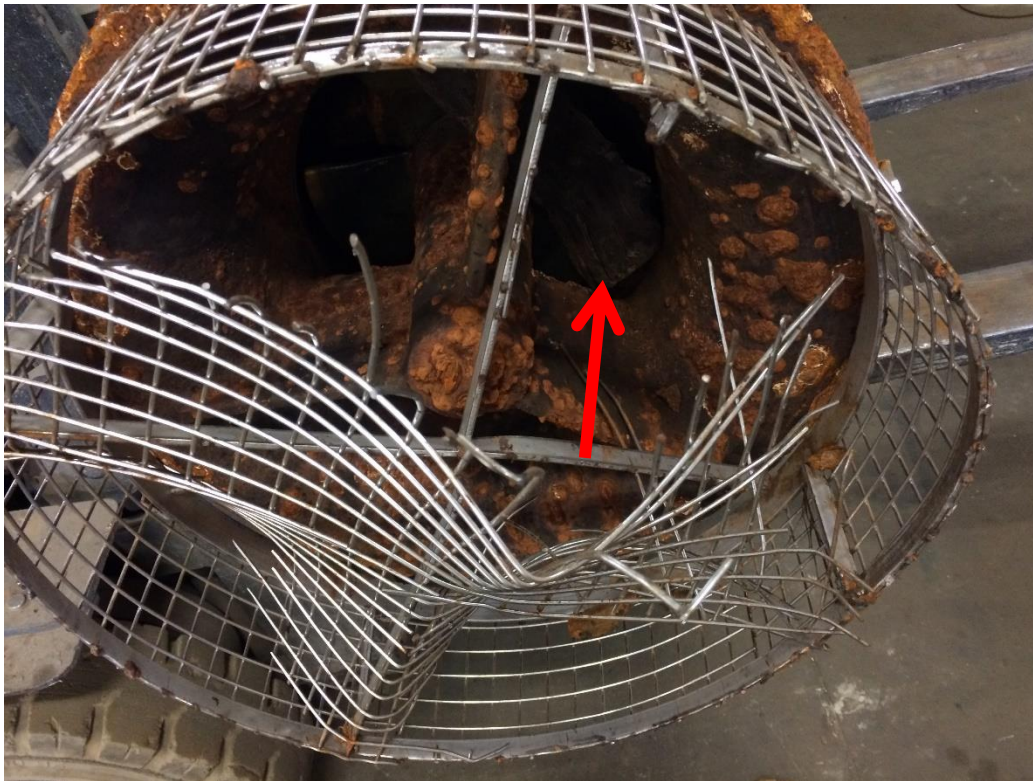
Figure 10: The basket was found to be destroyed upon arrival, and a large piece of wood was found lodged in the impeller. The basket strainer will need to be replaced.

- 5) The bowl assembly was found with a destroyed basket strainer and a large piece of wood lodged in the bottom impeller. This piece of wood caused the bottom impeller to break loose from the collette. The collette then spun in the bore, causing abnormal wear. The bottom impeller bore is now oversized and will not properly seat on a new collette. The bottom impeller needs to be replaced. The black ring in the bore of the top impeller is indicative of improper impeller seating on the collette.

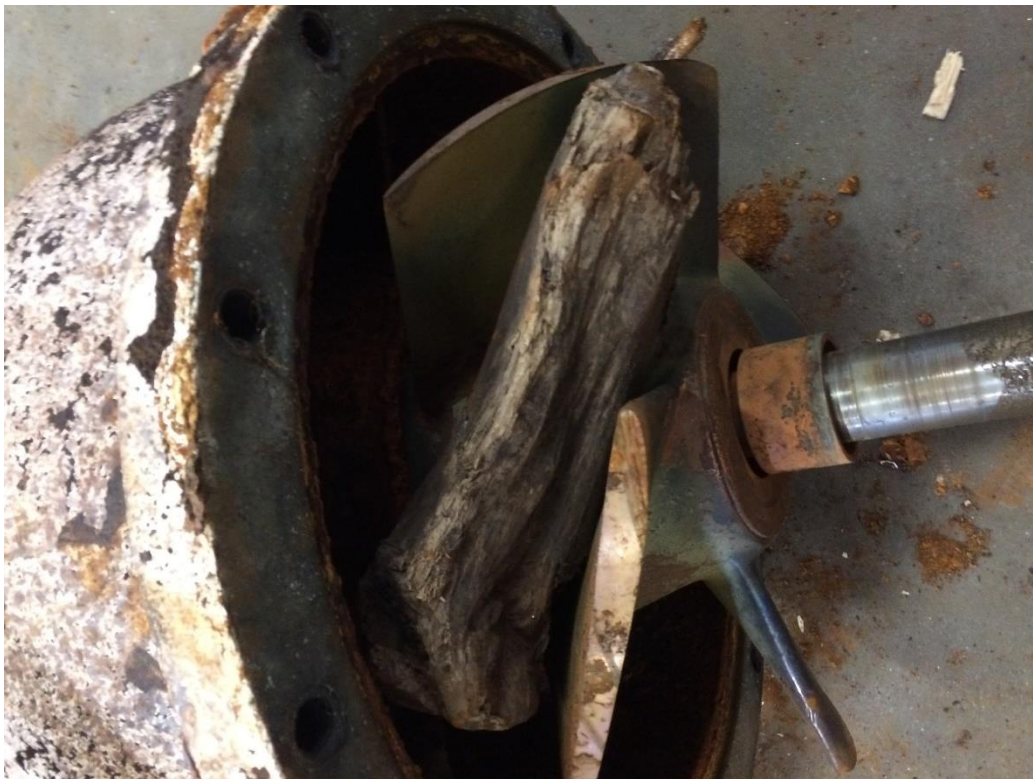
Figure 11: Detail showing the large piece of wood that was found in the bowl.

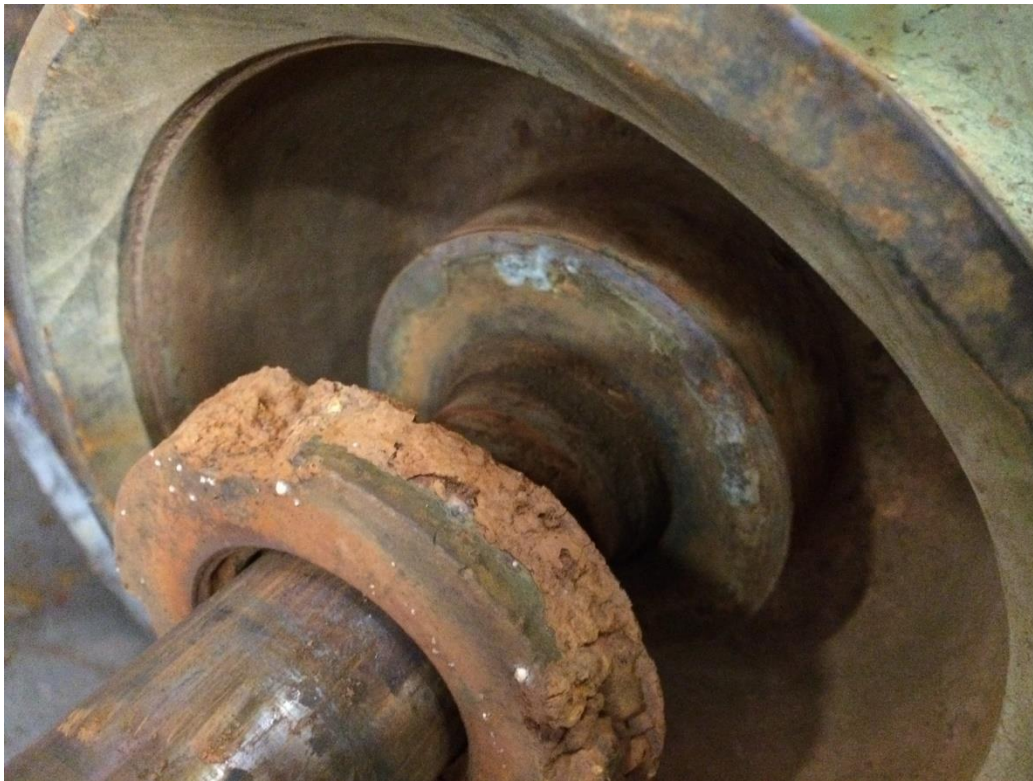
Figure 12: The carbon steel impeller nut is severely rusted and had broken loose of the threaded collette. It will need to be replaced.

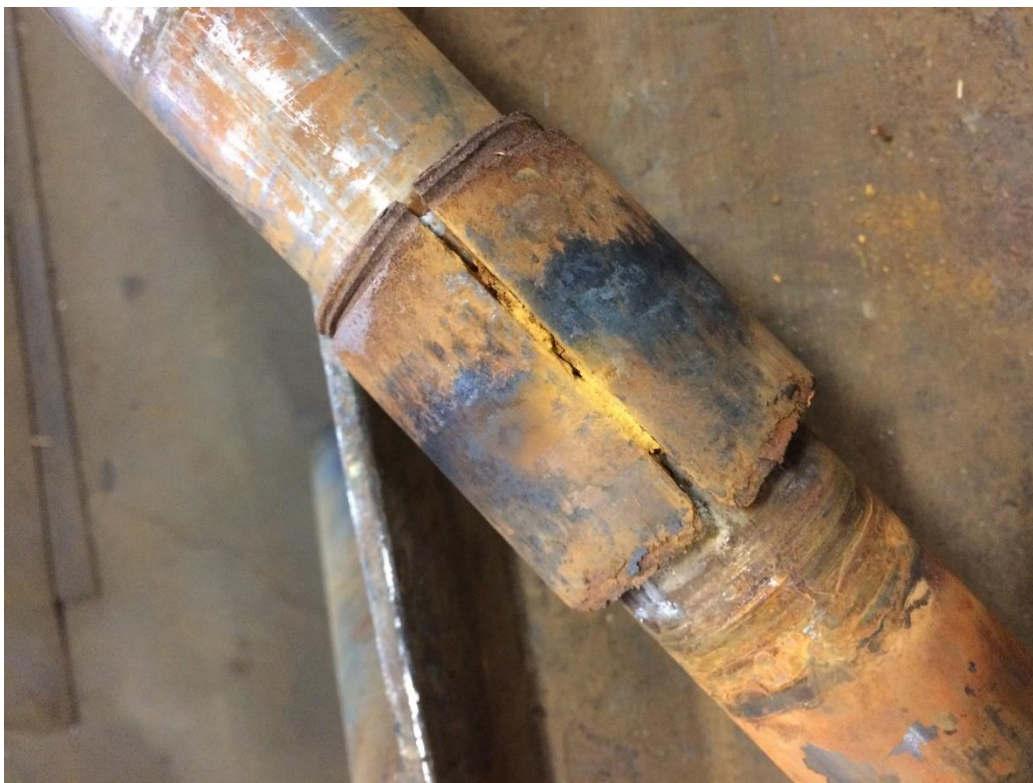
Figure 13: The carbon steel collettes will need to be replaced, as the impellers have spun on the collettes.

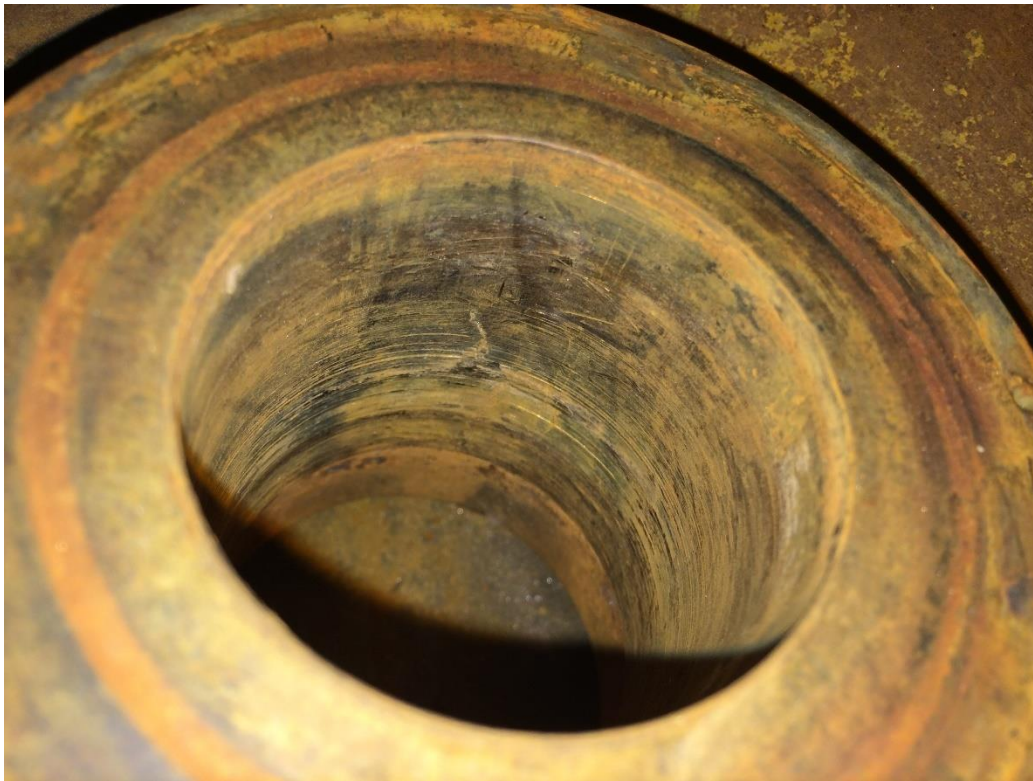
Figure 14: The piece of wood lodged in the bottom impeller caused it to break loose from the collette, and the collette spun in the bore. This caused the bore to become oversized.

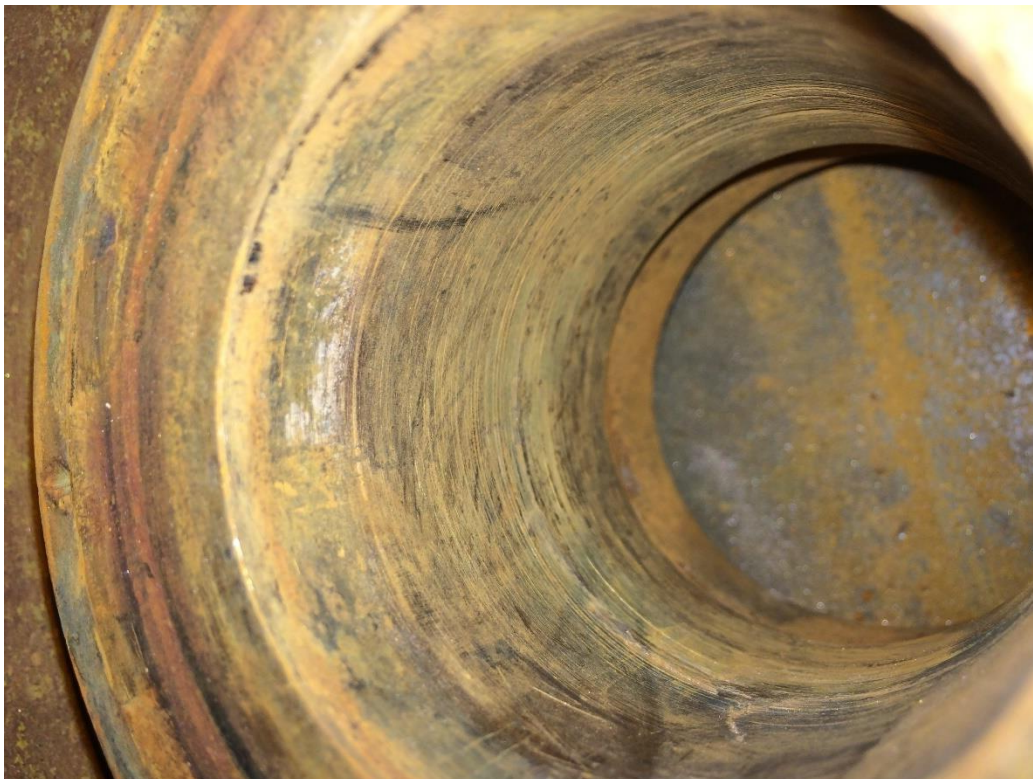
Figure 15: Detail showing a different angle of the bottom impeller's bore.

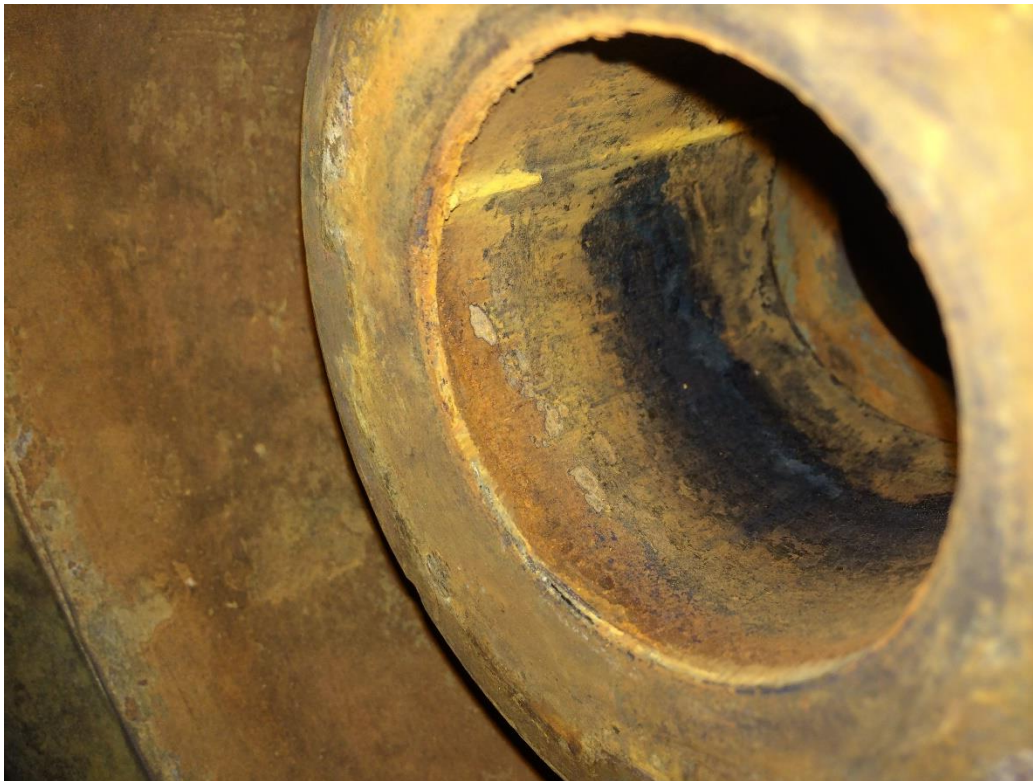
Figure 16: The black area in the bore is indicative of a presence of water between the collette and impeller bore.

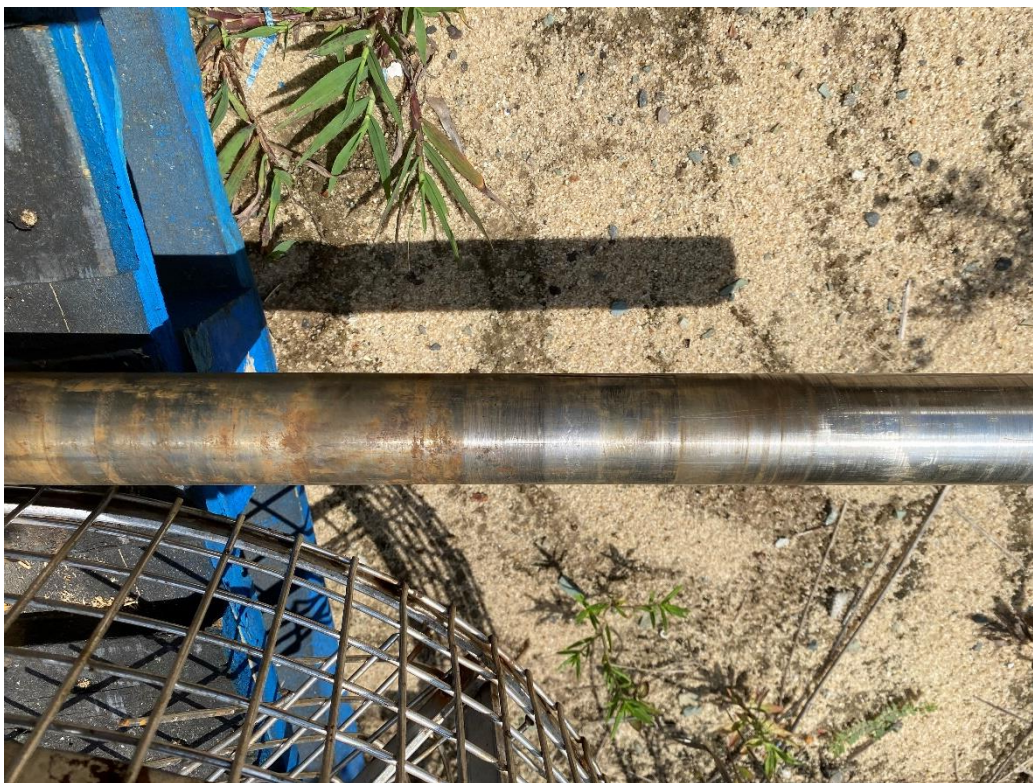
Figure 17: The bowl shaft is worn in the bearing areas and will need to be replaced.

- 6) The bowl shaft is worn in the bearing areas and, in turn, the bowl bearings are too worn to be reused. The bowl shaft and all bowl bearings will need to be replaced. All bowl castings show signs of pitting and corrosion on the flanges and on the suction bell lip. With the current state of the castings, and the work required to repair the impellers, it is more economical to replace the bowl assembly.

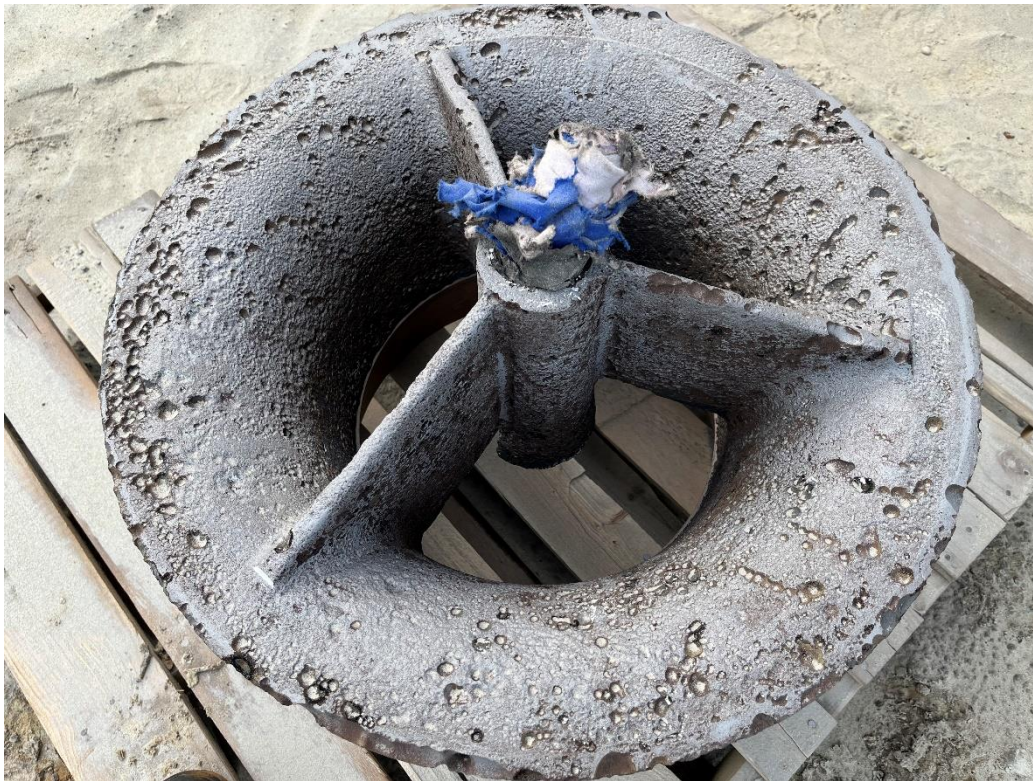
Figure 18: The suction bell has some major pitting, as well as some corrosion on the bell lip.

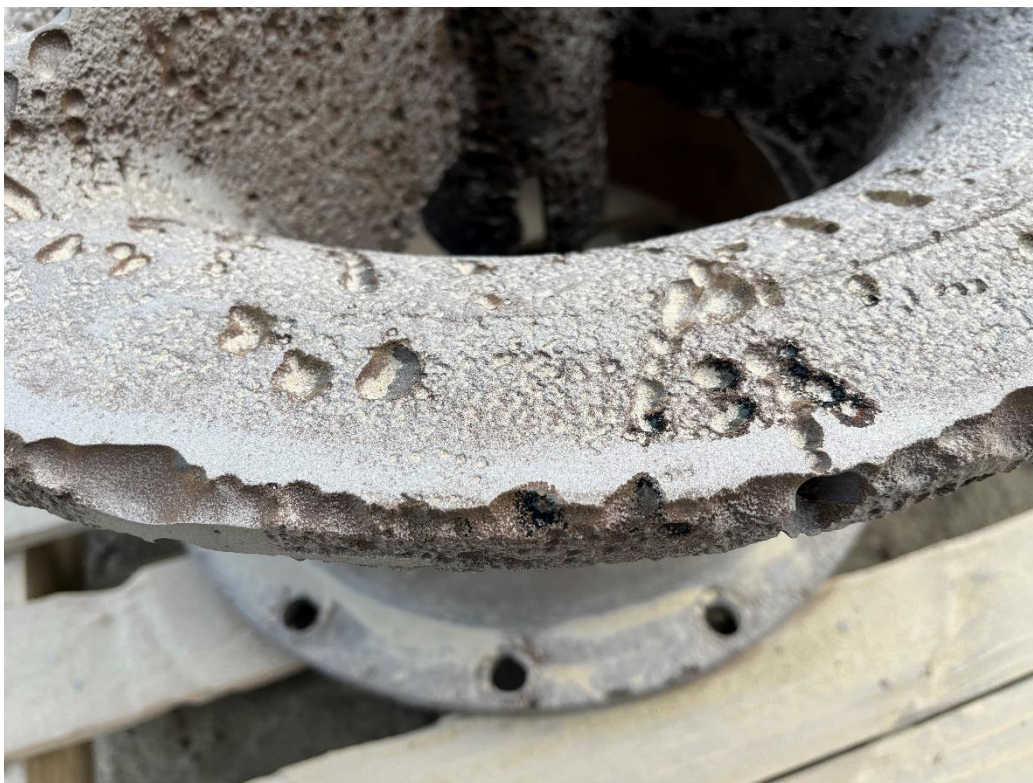
Figure 19: Detail showing the corrosion on the suction bell lip.

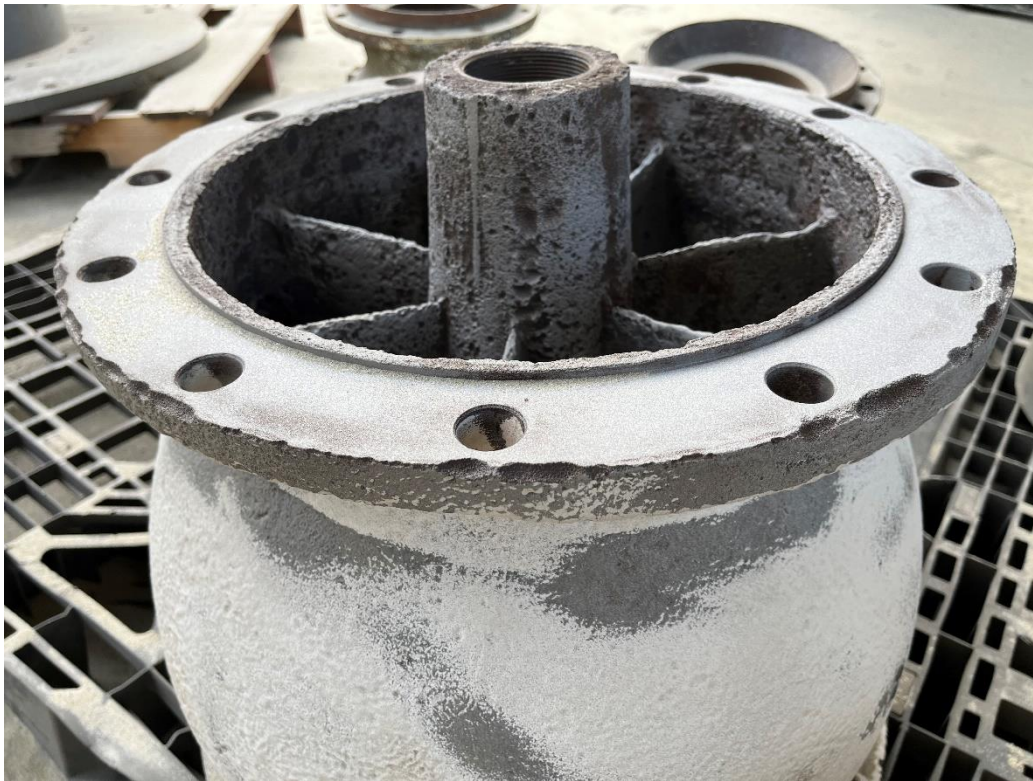
Figure 20: The bowl castings have some slight pitting and corrosion on the flanges.

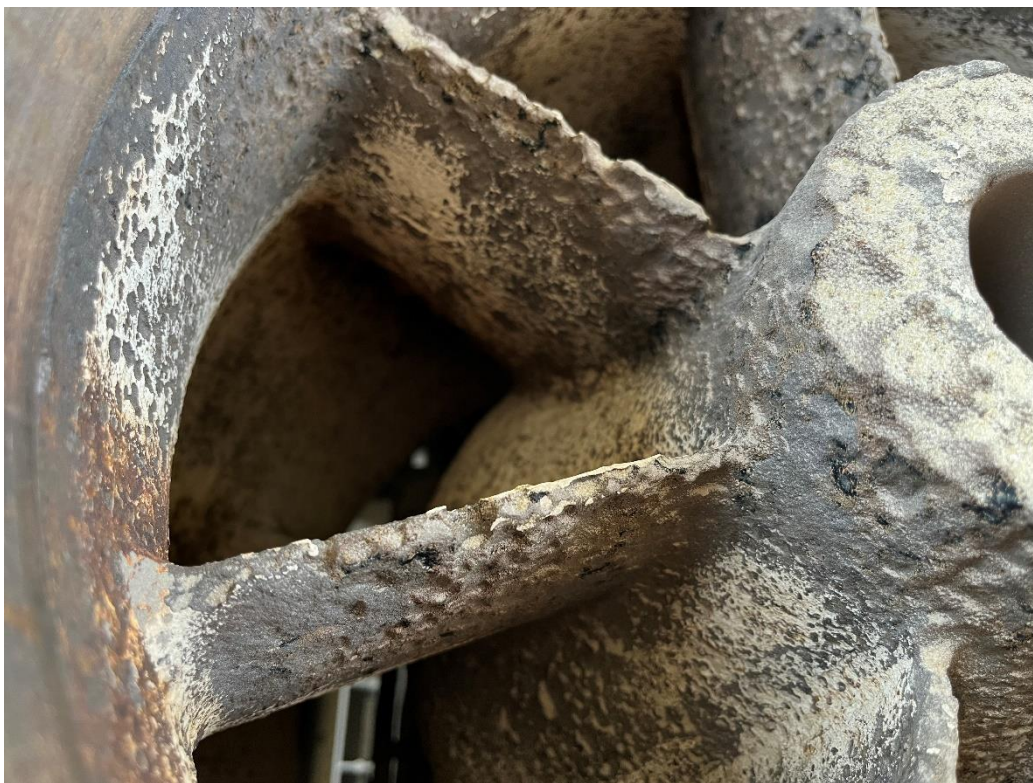
Figure 21: The edge of the vanes in both bowls are also pitted and corroded.
